DEPARTMENT OF TRANSPORTATION**DIVISION OF ENGINEERING SERVICES**

Quality Assurance and Source Inspection

Contract #: 04-0120F4Cty: SF/ALA Rte: 80 PM: 13.2/13.9File #: 1.28**WELDING INSPECTION REPORT****Resident Engineer:** Casey, William**Address:** 333 Burma Road**City:** Oakland, CA 94607**Report No:** WIR-029218**Date Inspected:** 06-Mar-2013**Project Name:** SAS Superstructure**OSM Arrival Time:** 1500**Prime Contractor:** American Bridge/Fluor Enterprises, a JV**OSM Departure Time:** 1730**Contractor:** American Bridge/Fluor Enterprises, a JV**Location:** Job Site**CWI Name:** As noted below**CWI Present:** Yes No**Inspected CWI report:** Yes No N/A**Rod Oven in Use:** Yes No N/A**Electrode to specification:** Yes No N/A**Weld Procedures Followed:** Yes No N/A**Qualified Welders:** Yes No N/A**Verified Joint Fit-up:** Yes No N/A**Approved Drawings:** Yes No N/A**Approved WPS:** Yes No N/A**Delayed / Cancelled:** Yes No N/A**Bridge No:** 34-0006**Component:** SAS OBG**Summary of Items Observed:**

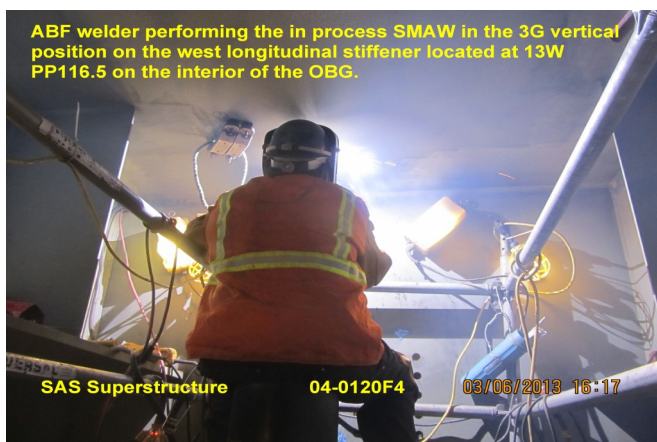
This QA Inspector made random observations of ABF welder Chris Bruce #8901 performing the SMAW process in the 3G vertical position utilizing E9018 electrodes on the Longitudinal Stiffeners located at 13W PP116.5-W2-LSW. The welder was observed utilizing WPS ABF-D1.5-1012-3 for SMAW. The welder was observed preheating the welds prior to welding. Other welding parameters as inspected by the QC Inspector were recorded as 138 amperes and appeared to be in compliance with the WPS noted above. This QA Inspector made subsequent observations throughout the remainder of the shift to monitor quality and noted that the work at this location appeared to be in general conformance with the contract specifications.
